# TECHNICAL NOTE

D-1158

STRUCTURAL DYNAMIC EXPERIENCES OF THE X-15 AIRPLANE

By Gareth H. Jordan, Norman J. McLeod, and Lawrence D. Guy

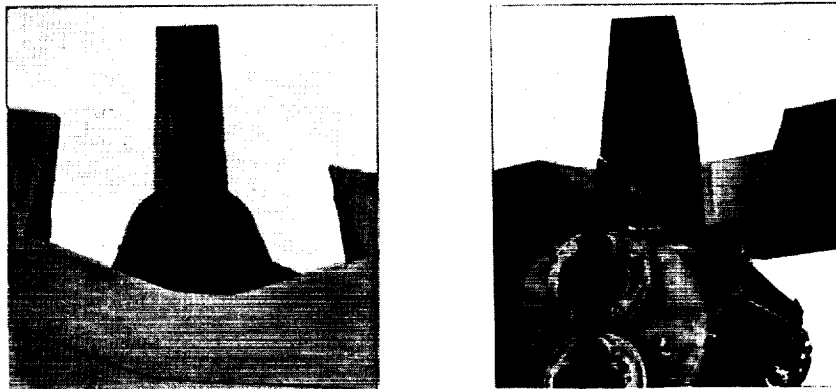
Initial captive flights were made with the original construction before retrofit of the modifications was accomplished. Structural failures were found in the upper vertical tail after the third captive flight. The failures, which were similar to those that occurred during the siren tests, consisted of failure of the corrugated ribs where they are flanged over to attach to the cap strip. The most extensive failure was a complete separation of the rib from the flange for approximately 18 inches on the side away from the B-52 jet engines. Subsequent investigation showed, however, that the failures were largely a result of a

previously unsuspected source - the turbulence created by the X-15 pylon and the B-52 wing cutout.

Figure 3 shows the upper vertical tail located in the cutout of the trailing edge of the B-52 wing. On the left is the upper vertical tail in the wing cutout, as viewed over the upper surface of the B-52 wing. On the right is a rear view of the upper vertical tail in the wing cutout. The X-15 pylon and the blunt surface ahead of the X-15 upper vertical tail should be noted. Pressure measurements were made on the sides of the B-52 wing cutout to measure the environment of the vertical tail. These results are shown in figure 4. The magnitude of the pressure fluctuations  $\Delta p$  plotted against dynamic pressure increases with dynamic pressure and has a value of about 40 percent of dynamic pressure and a frequency of about 100 cps. These pressures converted to equivalent noise levels have a value of about 160 decibels at a dynamic pressure of 300 lb/sq ft and 154 decibels at a dynamic pressure of 150 lb/sq ft. Estimates of the fatigue life of the modified construction indicated an acceptable fatigue life in this environment. The modified tail is still subjected to the high-turbulence environment during captive flight and no further difficulty has been experienced to date.

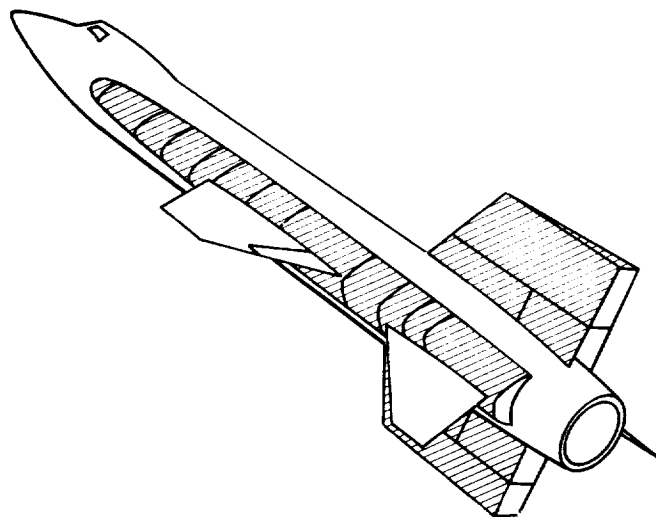
Figure 8

Panel flutter, on the other hand, has occurred in flight and has required modification of extensive areas of the fuselage side fairing and vertical tails which are shown as shaded areas in figure 8. The side-fairing panels consisted of a series of flat rectangular panels stiffened by a corrugated inner skin with the corrugations oriented normal to the flow. This orientation was chosen to allow thermal buckling and thus minimize thermal stresses, but of course it is not desirable from a panel-flutter standpoint. With respect to the vertical tail, the skin panels were unsupported over a length of about 60 inches

with a rib spacing of about 6 inches. This resulted in long narrow panels having length-width ratios of about 10.

Panel flutter of the fuselage side-fairing panels was experienced early in the flight program, however, and resulted in a severe vibration felt throughout the airplane. Strain gages were installed on the side-fairing panels, and panel flutter was detected at dynamic pressures as low as 650 lb/sq ft and identified as the source of vibration. Wind-tunnel tests on a full-scale side-fairing panel were initiated in the Langley Unitary Plan wind tunnel. During these tests, the panel flutter that was measured was in good agreement with the flight measurements. At the completion of these tests, cracks were found which originated at drain holes in the corrugations and extended outward to the base of the corrugation. Inspection of the airplane revealed several panels which had similar fatigue cracks. Previous wind-tunnel and analytical studies had indicated that a simple modification would be effective in preventing panel flutter on this type of panel. The modification, shown in figure 9, consisted of a hat-section stiffener riveted to the corrugations and extending in the streamwise direction. This modification was installed on the test specimen and tested in the Langley Unitary Plan wind tunnel. These tests served to clear the airplane for flight up to dynamic pressures of 2,000 lb/sq ft. Proof tests were later conducted in the Langley 9- by 6-foot thermal structures tunnel under conditions of aerodynamic heating at dynamic pressures up to 3,250 lb/sq ft and cleared the airplane for flight to dynamic pressures of 2,500 lb/sq ft. A total of 38 side-fairing panels, ranging in size from 12 by 15 inches to 23 by 34 inches, were stiffened in this manner on each X-15 airplane for panel flutter.

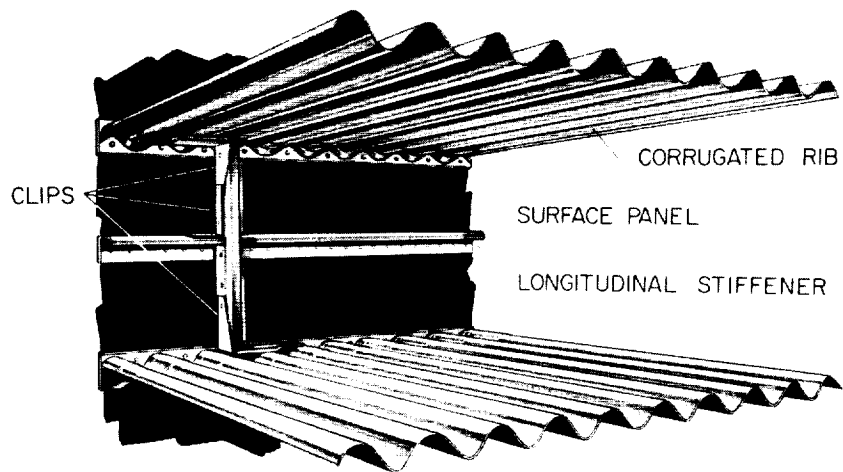
Figure 11

Panel flutter of the vertical tail also became of concern during proof tests to clear the airplane for classical flutter. Consequently, a second series of tests on the vertical stabilizer was planned to investigate panel flutter. Tests were made in the Ames 9- by 7-foot tunnel at a Mach number of 1.7 and dynamic pressures up to 1,300 lb/sq ft. Flutter was obtained on the skin panels with a length-width ratio of 10 and also on the closure rib. As a result of these tests, the affected panels were stiffened by North American Aviation, Inc., and flights with the stiffened stabilizer were restricted to dynamic pressures no greater than 1,500 lb/sq ft at Mach numbers up to 3.0.

The modifications made to the vertical tail for panel flutter are shown in figure 11. The modification consists of J-section stiffeners riveted longitudinally on the inner surface of the skin at the centerline of the panel. In addition, lateral stiffeners were riveted to the skin near the panel centers and tied into the longitudinal stiffeners. Tests have shown that lateral stiffeners are ineffective in preventing flutter unless they are firmly restrained against rotation about the line of attachment to the panel. Other areas of the vertical tail in which panel flutter was experienced were on the corrugation-stiffened panels, similar to the side-fairing panels. The modification consisted of a single, light-weight hat section riveted to the backs of the corrugations along the longitudinal centerline. Proof tests were made on a full-scale ventral incorporating all modifications for panel flutter. These tests were made at a Mach number of 3.0, a dynamic pressure of 3,250 lb/sq ft, and a stagnation temperature of 660° F, with no evidence of flutter.
