Orbital impacts and the Space Shuttle windshield

Karen S. Edelstein

NASA/Lyndon B. Johnson Space Center (JSC)
 ES2/Structures and Dynamics Branch
 Houston, TX 77058

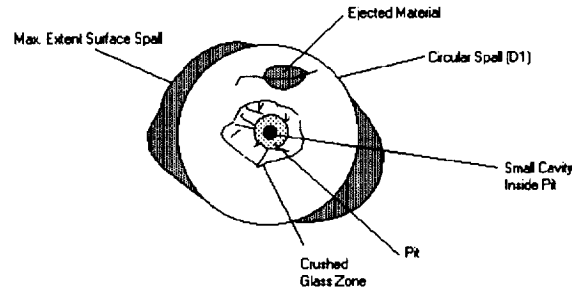
Hypervelocity impact pits in fused silica have very specific characteristics. The visible crater is roughly circular, with a central pit identified by denser crazing. Figure 2 shows a sketch of a typical crater.

Typical hypervelocity crater in fused silica glass

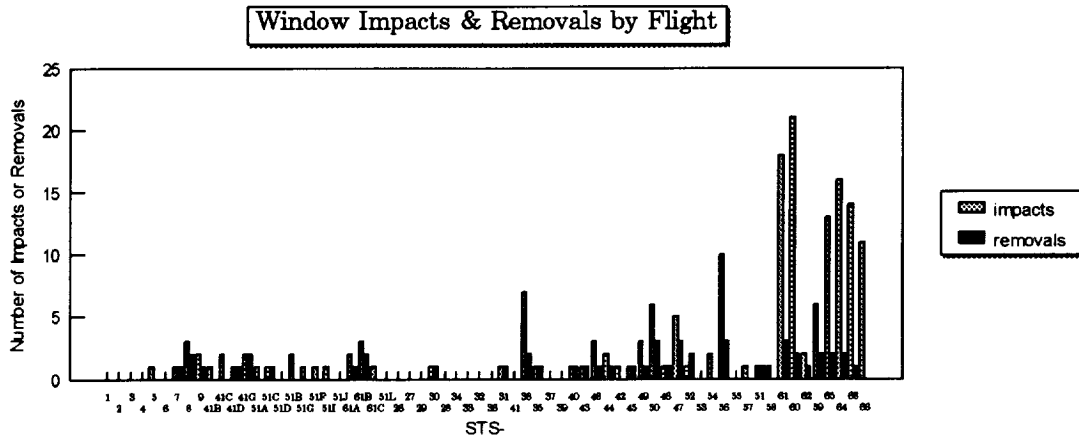
Figure 4 shows the program history of impacts and removals. The noticeable increase in reported impacts may be due to recently improved inspection procedures at KSC. Some of the impacts reported in recent flights may be artifacts from earlier missions.

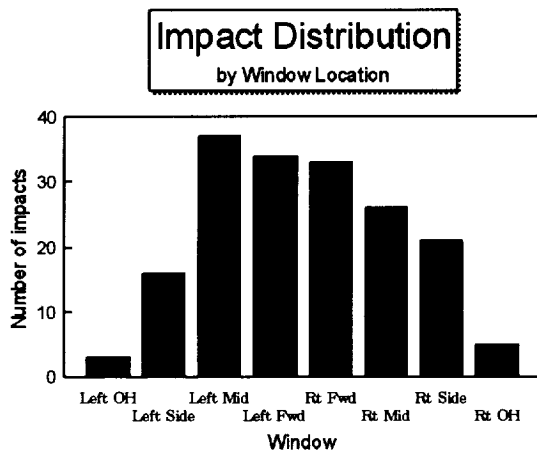
Figure 5 shows the flight data, which demonstrates this expected impact distribution, except for the left middle and side windows, which have more and fewer impacts compared to the right windows, respectfully. A review of the Shuttle program's flight history¹ indicates that the right wing is directed into the velocity vector more frequently than the left, and the nose is in the velocity vector the most of any identifiable direction (see Figure 6). The "other" directions in Figure 6 comprise tail forward, bottom forward, and random or varied orientations. The discrepancies for the left side of the vehicle could be due to inspection errors; possibly the "other" velocity vector orientations are responsible for the unexpected distribution.

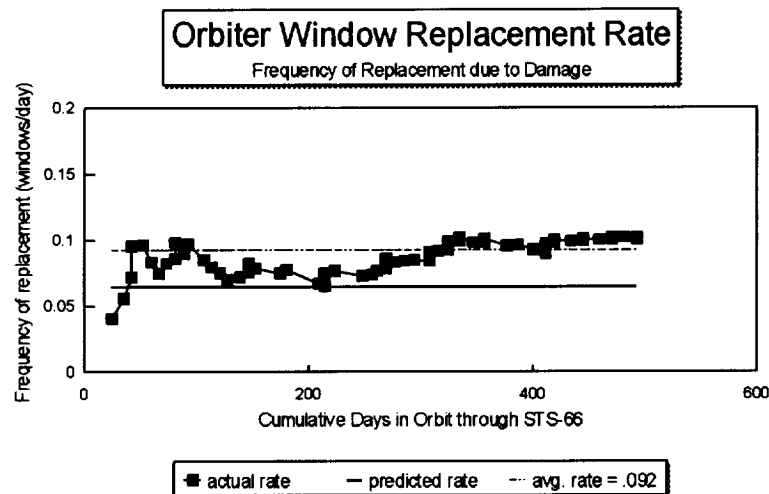
Figure 9

As shown in Figure 4, the replacement rate has not varied much over the history of the Shuttle program. The rate is plotted in Figure 9, which shows the flight-by-flight variations, the average for the whole program, and the predicted rate. The replacement rate predicted by the contractor at the beginning of the program only considered micro-meteoroid impacts, but used a penetration equation for fused silica that has since been shown to predict much deeper craters than more recently developed equations². Therefore, the predicted rate of replacement, which includes consideration of the impact rate as well as the effects of the damage on window strength, is reasonably close to the actual rate, which is due to the micrometeoroid and the man-made debris environments.

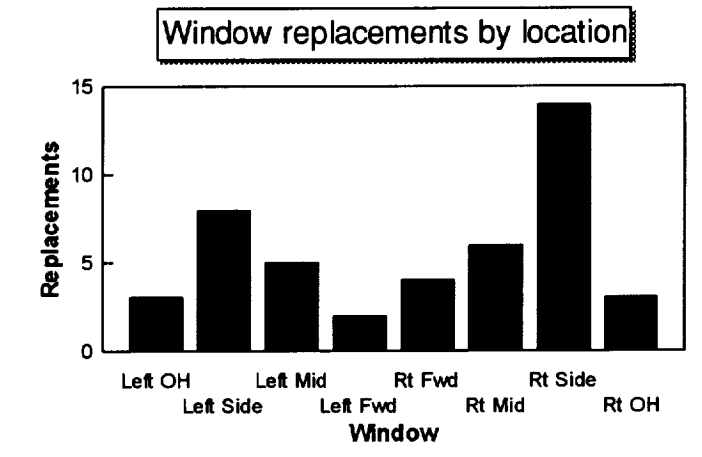
As stated earlier, whether or not a window is replaced after an impact pit is discovered depends on the stress analysis and life assessment performed by KSC and JSC engineers. Because of the nature of the window system design, the side and overhead windows are the most sensitive to impact damage.

Figure 10 shows that the side windows have been replaced the most frequently. The sensitivity of these windows is especially obvious for the overheads, where almost every impact damage has resulted in a window replacement. Figure 11 shows the distribution of impact depths for all impacts and for impact pits that resulted in window replacement.

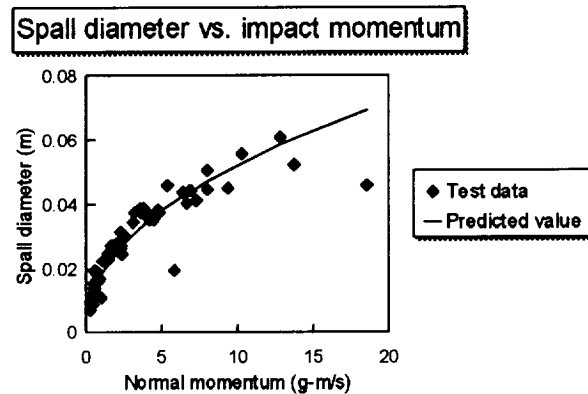
variety of projectile diameters and materials and within a range of velocities from 2 km/s to 8 km/s. Measurements of the pit diameters and depths were made with the same technique used at KSC on Shuttle windows. The diameters and depths were then analyzed to determine a penetration equation for fused silica.⁴ Figure 12 shows the spall diameters plotted as a function of the impact's normal momentum. The equation relating spall diameter to momentum is:

$$D_1 = .0184(m_p V^*)^{.454} \quad (1)$$

This equation is 88% correlated. A similar relationship exists between spall diameter and impact energy, but the *penetration depth* and impact parameters are not yet correlated with any comparable confidence.
