# TECHNICAL NOTE

D-1158

STRUCTURAL DYNAMIC EXPERIENCES OF THE X-15 AIRPLANE

By Gareth H. Jordan, Norman J. McLeod, and Lawrence D. Guy

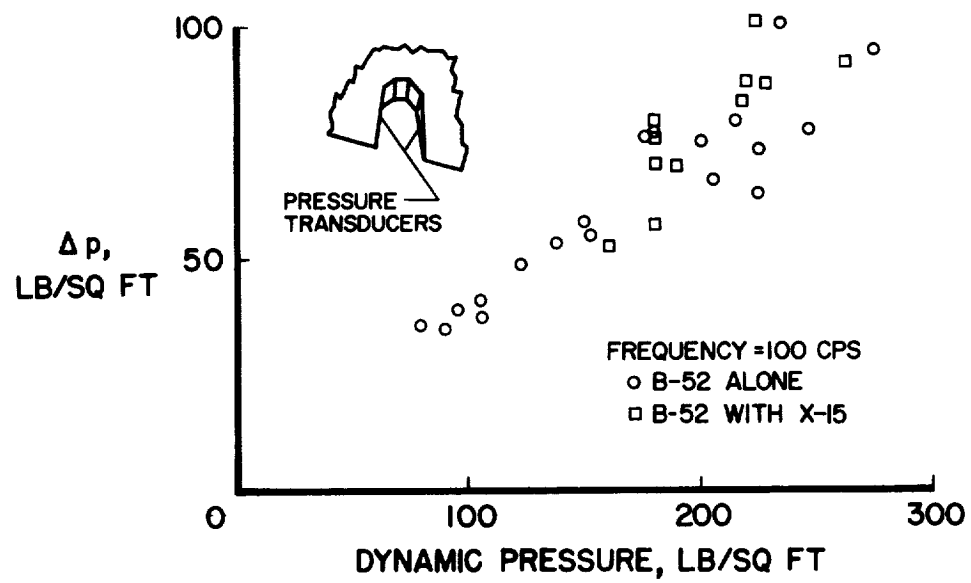
Figure 4

Figure 3 shows the upper vertical tail located in the cutout of the trailing edge of the B-52 wing. On the left is the upper vertical tail in the wing cutout, as viewed over the upper surface of the B-52 wing. On the right is a rear view of the upper vertical tail in the wing cutout. The X-15 pylon and the blunt surface ahead of the X-15 upper vertical tail should be noted. Pressure measurements were made on the sides of the B-52 wing cutout to measure the environment of the vertical tail. These results are shown in figure 4. The magnitude of the pressure fluctuations  $\Delta p$  plotted against dynamic pressure increases with dynamic pressure and has a value of about 40 percent of dynamic pressure and a frequency of about 100 cps. These pressures converted to equivalent noise levels have a value of about 160 decibels at a dynamic pressure of 300 lb/sq ft and 154 decibels at a dynamic pressure of 150 lb/sq ft. Estimates of the fatigue life of the modified construction indicated an acceptable fatigue life in this environment. The modified tail is still subjected to the high-turbulence environment during captive flight and no further difficulty has been experienced to date.

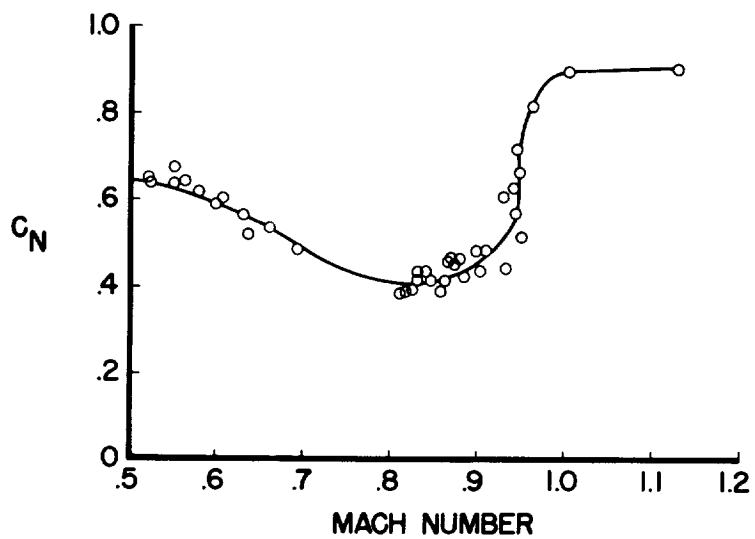
Figure 6

The remainder of the paper is devoted to some of the problems and experiences with the X-15 airplane alone. The buffet boundary established for the X-15 airplane is shown in figure 6 in terms of normal-force coefficient  $C_N$  plotted against Mach number. The data were taken

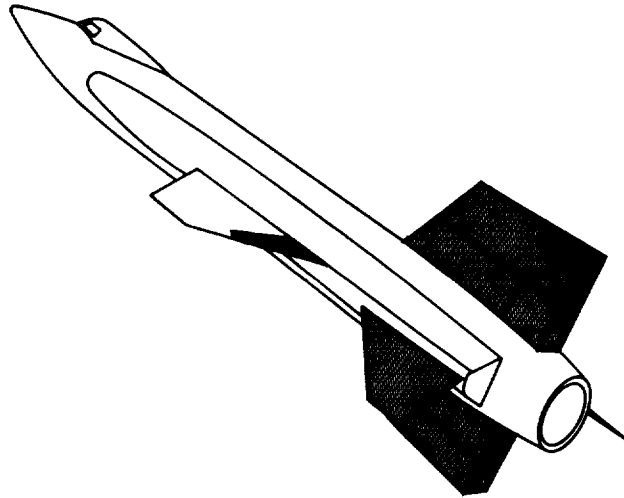
Figure 7

The components in which flutter considerations influenced the design of the X-15 are shown as shaded areas in figure 7 and include the horizontal and vertical tails and landing flaps. Adequate wind-tunnel tests were made on the various components to provide proof tests to 30 percent above the design dynamic pressure of 2,500 lb/sq ft. No indication of flutter has been experienced in X-15 flights.

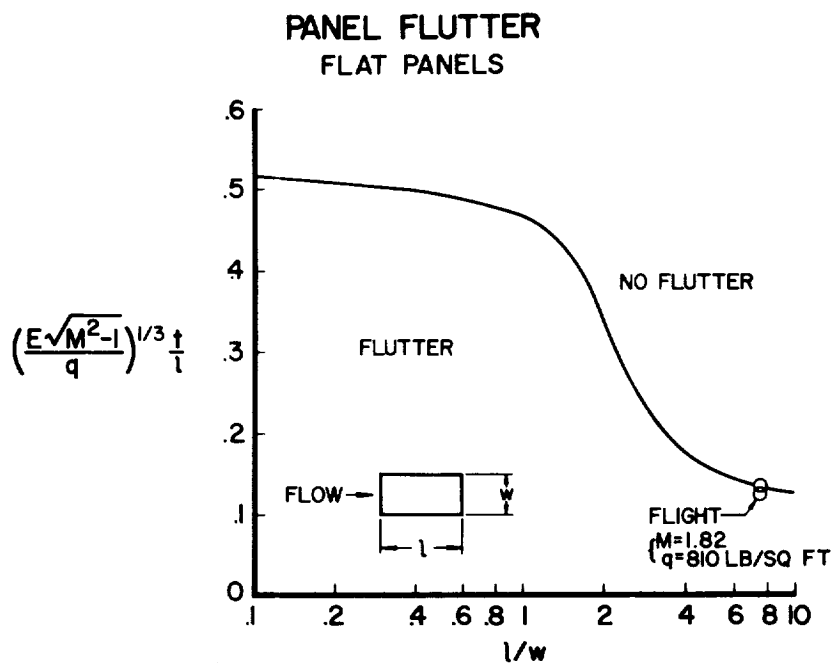
Figure 10

in figure 10. In this figure the flutter parameter  $\left(\frac{E\sqrt{M^2 - 1}}{q}\right)^{1/3} \frac{t}{l}$  is plotted as a function of length-width ratio  $l/w$ . The area under the curve is the flutter region and the area above the curve is free of flutter. The results of panel-flutter measurements in flight made on the flat rectangular panels on the vertical tail of the X-15 airplane are also shown in the figure. It is interesting to note the agreement between the flight data and the previously established envelope.
