Orbital impacts and the Space Shuttle windshield

Karen S. Edelstein

NASA/Lyndon B. Johnson Space Center (JSC)
 ES2/Structures and Dynamics Branch
 Houston, TX 77058

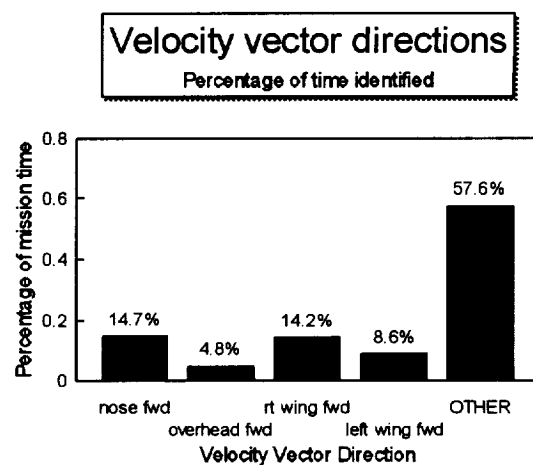
Figure 5 shows the flight data, which demonstrates this expected impact distribution, except for the left middle and side windows, which have more and fewer impacts compared to the right windows, respectfully. A review of the Shuttle program's flight history¹ indicates that the right wing is directed into the velocity vector more frequently than the left, and the nose is in the velocity vector the most of any identifiable direction (see Figure 6). The "other" directions in Figure 6 comprise tail forward, bottom forward, and random or varied orientations. The discrepancies for the left side of the vehicle could be due to inspection errors; possibly the "other" velocity vector orientations are responsible for the unexpected distribution.
