National Aeronautics and
Space Administration

FS-1999-06-013-GSFC

Hubble Space Telescope Servicing Mission 3A A NEW THERMAL BLANKET LAYER

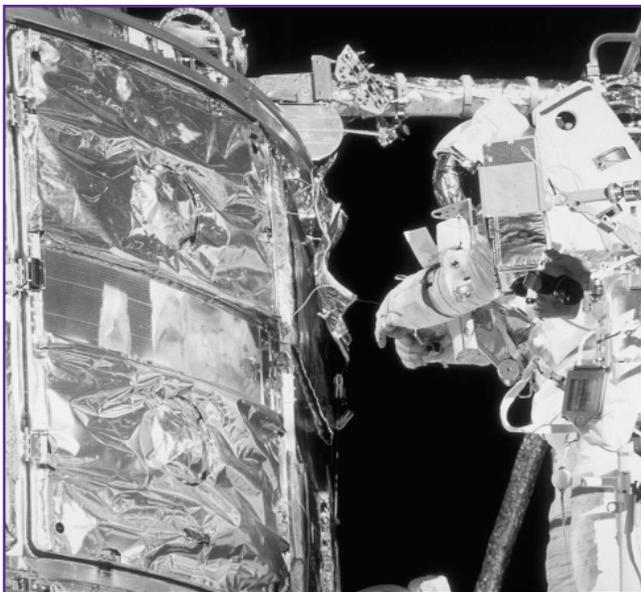
Although the cracks looked dramatic, the damage was limited to the outermost layer and did not

Astronaut Repairing Insulation During Servicing Mission 2

affect the insulation's protective function or Hubble's operation. With help from ground controllers, the astronauts used materials aboard the Space Shuttle Discovery in 1997 to fashion temporary patches. They installed them over the most critically damaged areas, mostly on Hubble's sun-facing side.

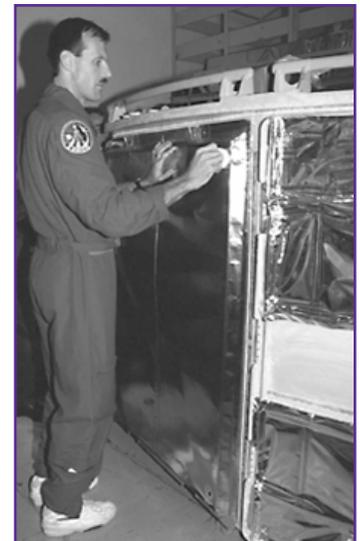
Astronaut Steve Smith installing a sheet of NOBL on the Hubble Mockup

Astronauts will install seven NOBL covers on Hubble's electronics bay doors. These covers are specially coated stainless steel foil trimmed to fit each particular door. Each cover is supported by a steel picture-frame structure. Expanding plugs, like common kitchen bottle stoppers, fit into door vent holes to allow quick installation.
